**DEVELOPMENT OF THE NEW ZEALAND EARTH BUILDING STANDARDS
NZS 4297:2020, NZS 4298:2020 AND NZS4299:2020**RICHARD WALKER¹ & HUGH MORRIS²¹ Consulting Chartered Professional Engineer, ESS, Takaka,² Department of Civil and Environmental Engineering, University of Auckland,**SUMMARY**

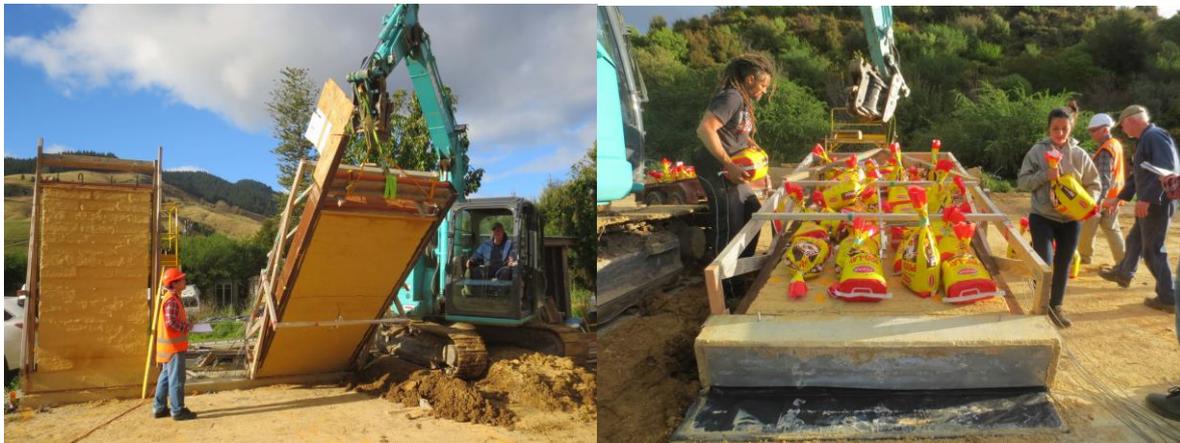
Photographs 1 and 2 – Full scale out of plane tests of low density adobe walls

Out of plane tests on wall panels of low density adobe were done in Nelson in 2017 using the same hinged foundations and test procedure used for the out of plane tests on adobe veneer walls in 2016. Details of the tests and test results are reported in *Xiao, Y. (2017) "Full scale testing of out of plane performance of light adobe earth walls for wind and earthquake."* The tilting of the panels was done using a 7 tonne excavator. The test arrangement is shown in Photograph 1. Both the 2.4 m high and 3.0 m high walls performed well and did not fail after being subjected to tilting both ways and then to 80 degrees. At 80 degrees tilt and a loading

equivalent of 1 g the deflection of the 3.0 m high wall at mid span was 39 mm. A larger deflection at mid-span was recorded during the tilt test on the 2.4 m high wall than on the 3.0 m high wall. At 80 degrees tilt the deflection was 48 mm. This was partly due to the nuts not being fully tightened at the top of the partly post-tensioned vertical reinforcing for the 2.4 m high wall. Additional loads were applied to the light adobe walls when tilted at 70 degrees using sandbags. Seventy-eight sandbags weighing 15 kg each were spread evenly over the tilted wall to provide a static loading equivalent of 2 g lateral acceleration as shown in Photograph 2. The uniformly distributed load was approximately equivalent to 2.9 kPa. Dynamic loading was applied by shaking the 3.0 m high wall at 80 degrees tilt with one layer of sandbags to produce a loading equivalent up to 2.2 g in an upward direction and 3.1 g in the downward direction. This loading would be equivalent to a very large earthquake with levels of shaking generally greater than experienced in the Christchurch 2011 and Kaikoura 2016 Earthquakes. The 3.0 m high light adobe wall performed well despite failure of one of the timber top-plate connections to the test rig. Only cracks along mortar joints were observed with no failure across the adobe bricks and no dislodged bricks. The full-scale tilt tests showed that light adobe with a density of 1000 kg/m³ is suitable for the ultimate design loads in earthquake prone areas and very high wind zones provided the adobe wall is reinforced in accordance with the New Zealand Earth Building Standards.
